Merkel & Associates, Inc.

June 18, 2014
M&A# 05-024-32

Final Canopy Kelp and Subtidal Reefs Survey Report In Support of the Morro Bay 2014 Maintenance Dredging Project W912PL-14-P-0014

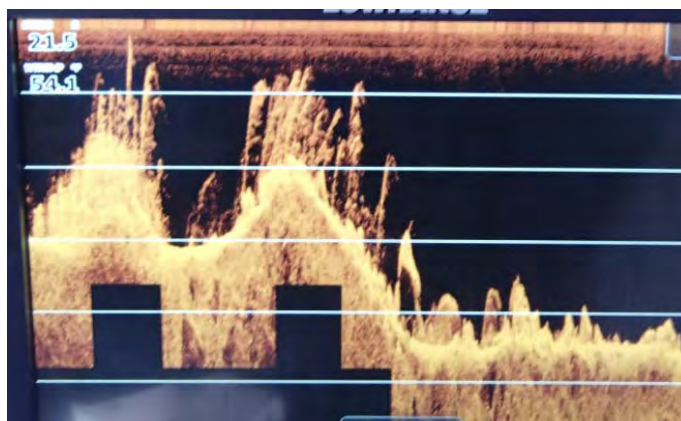
Sub-surface giant kelp on rocky bottom near Target Rock

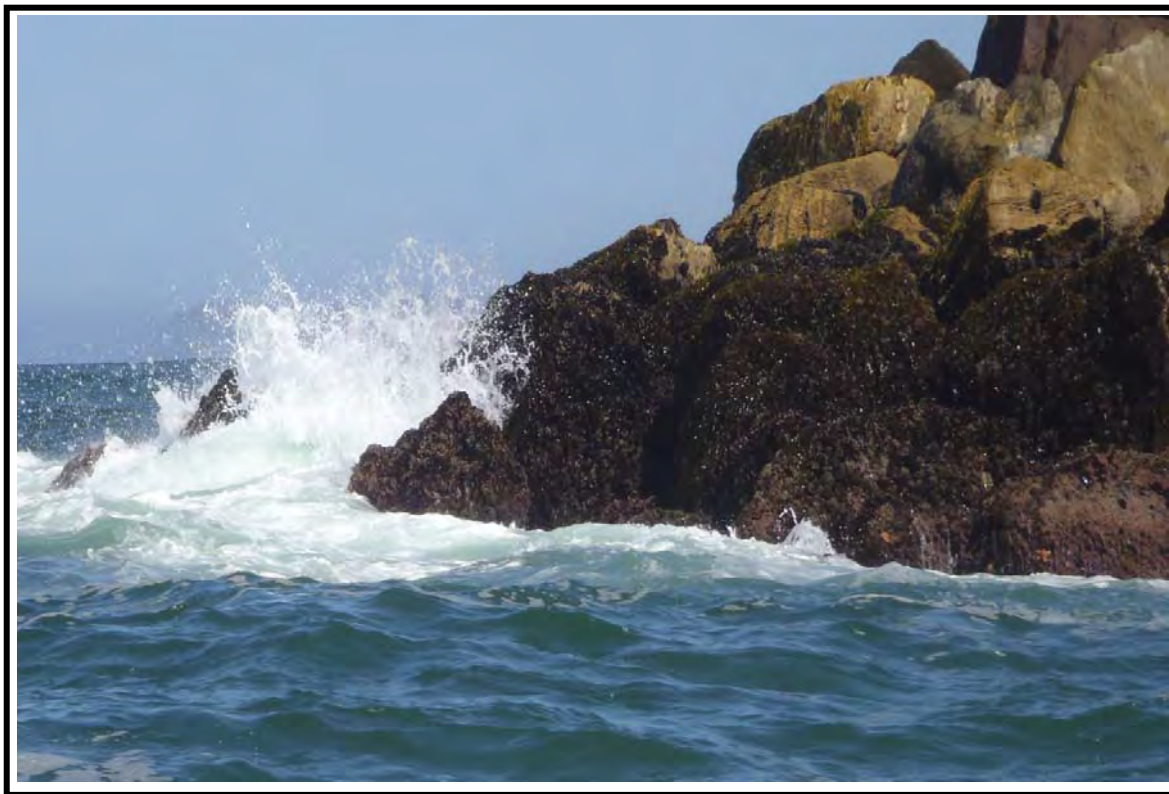
Photo Point 1a. Tip of the northern jetty exhibiting turf algae above scoured areas of coralline algae.

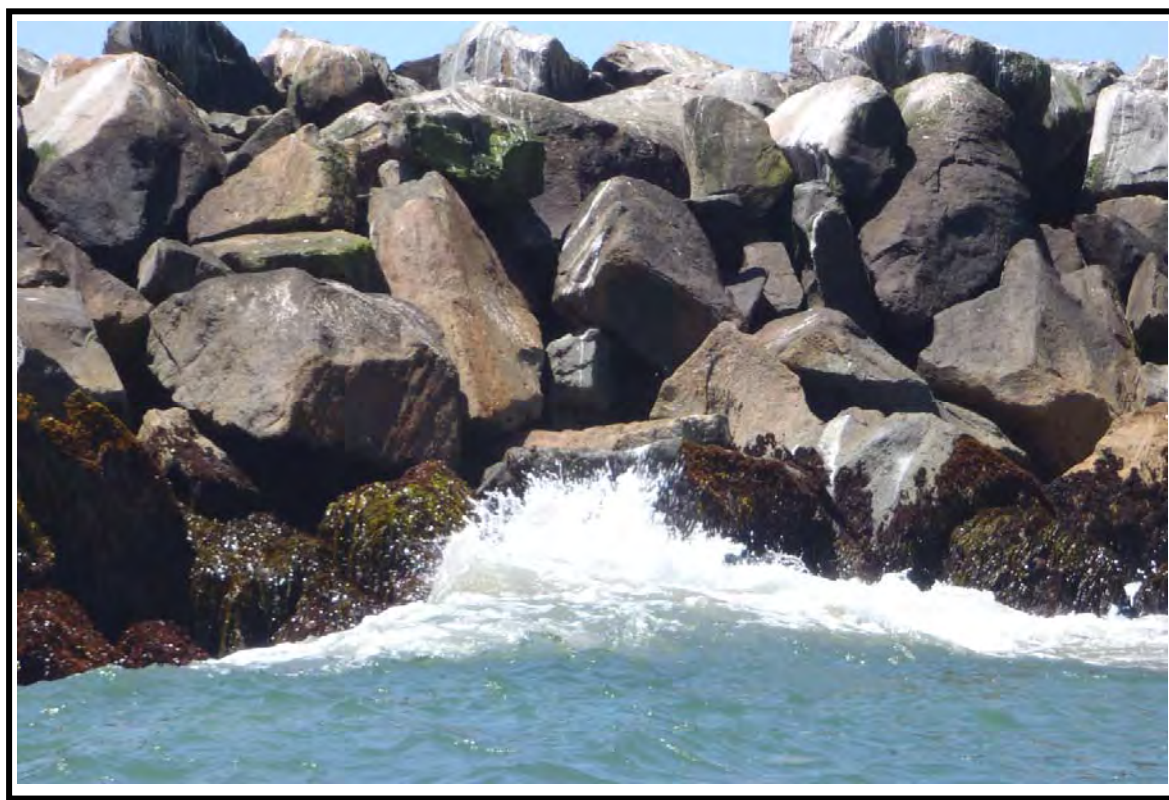
Photo 1b. Inside southern jetty illustrating the fairly barren rock of the splash zone above turf and foliose algal zones.

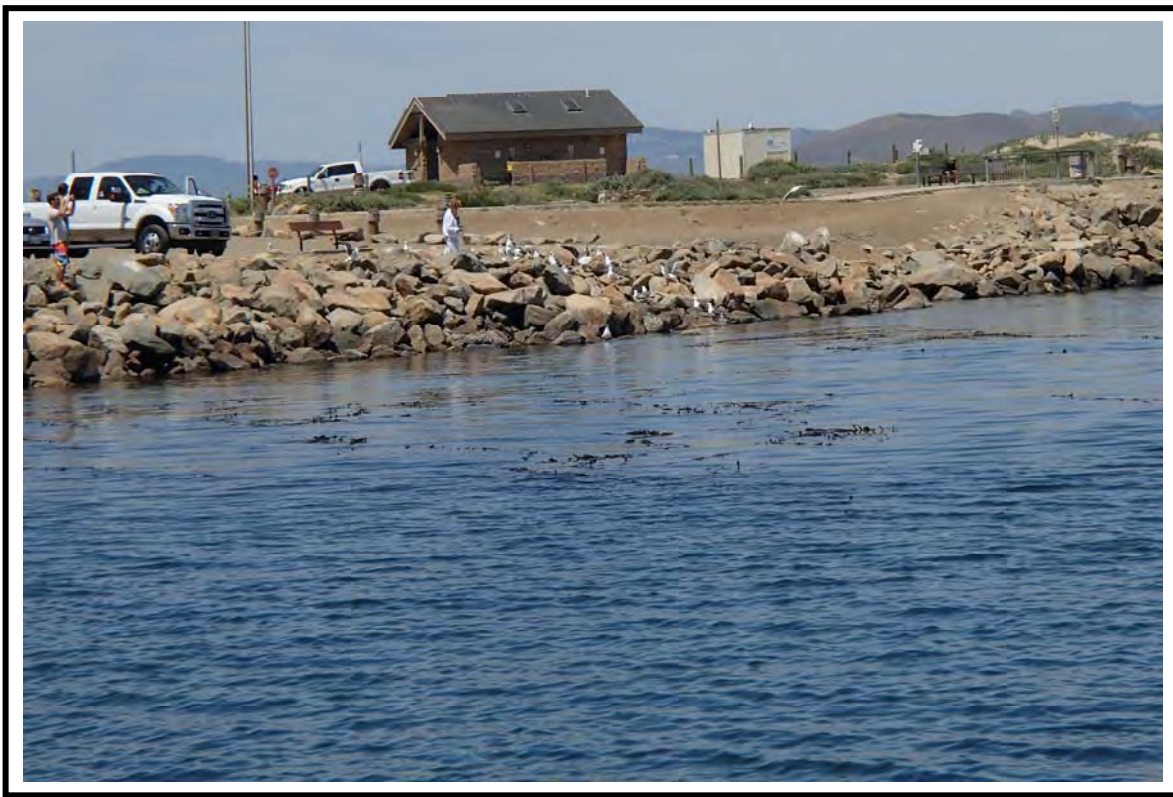
Photo 2a. Narrow giant kelp canopy located along northern shoreline east of Morro Rock.

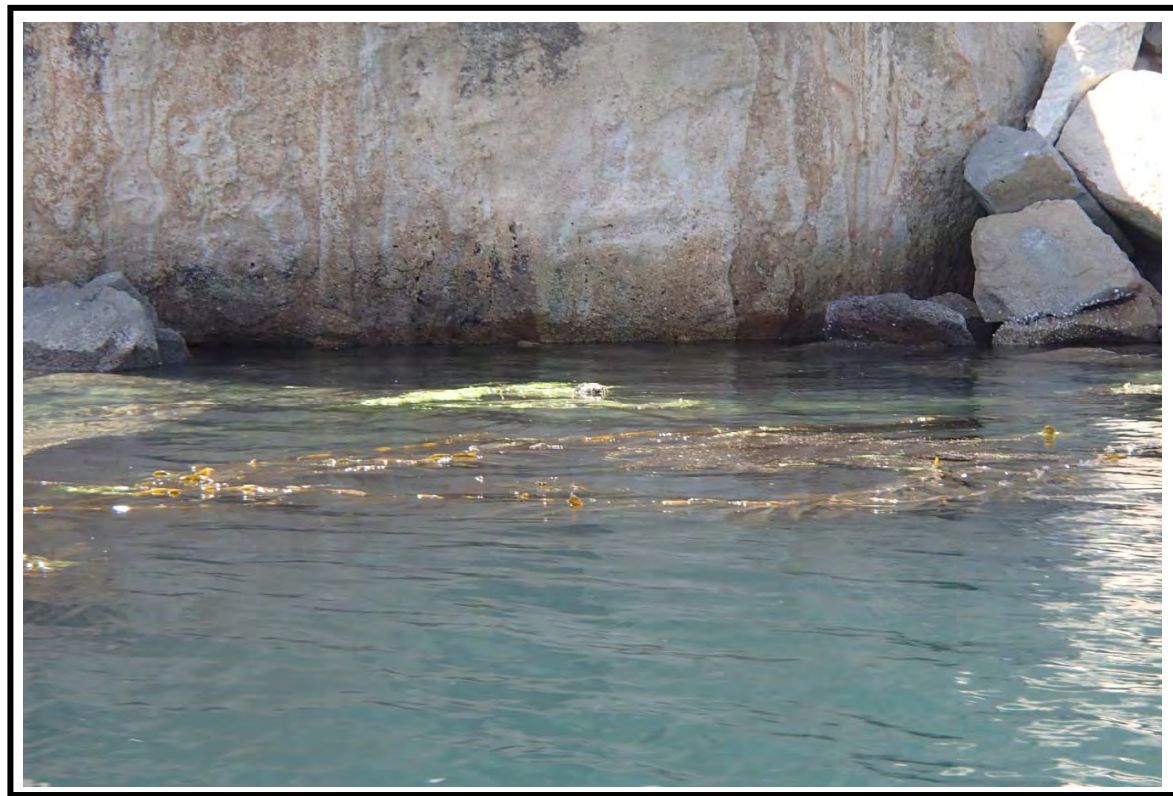
Photo 2b. Giant kelp in front of Target Rock along with *Enteromorpha* mat growing in the shallows.

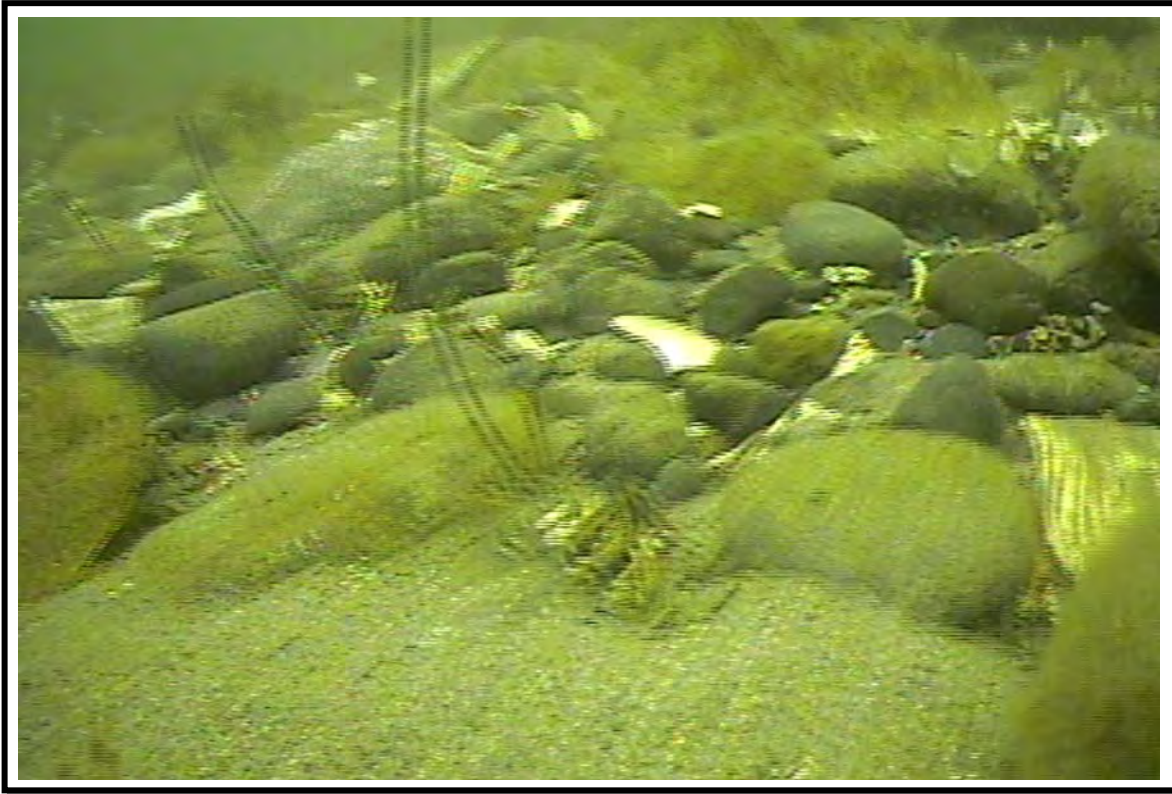
Photo 3a. Cobble beds intermixed with boulders at the western end of the Navy Channel.

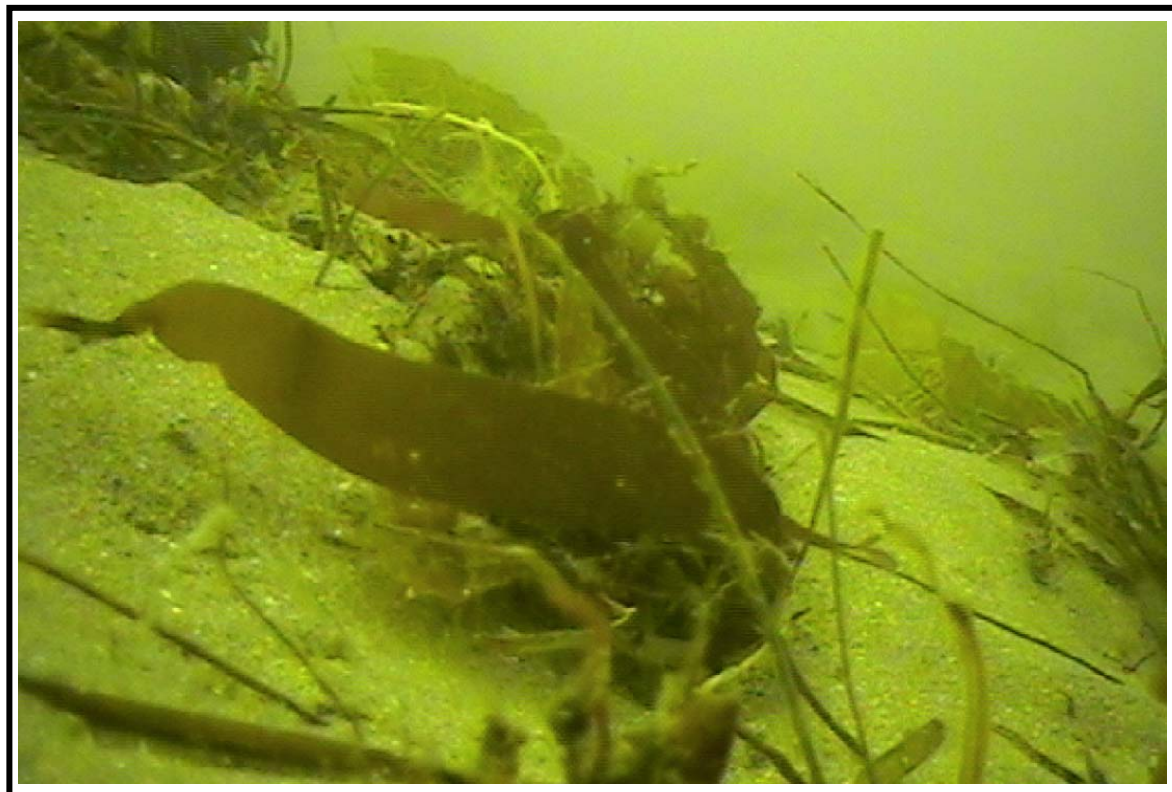
Photo 3b. Drift kelp and eelgrass debris trapped in active sand deposits to the north of the transition area of the channel inside the outer jetties.

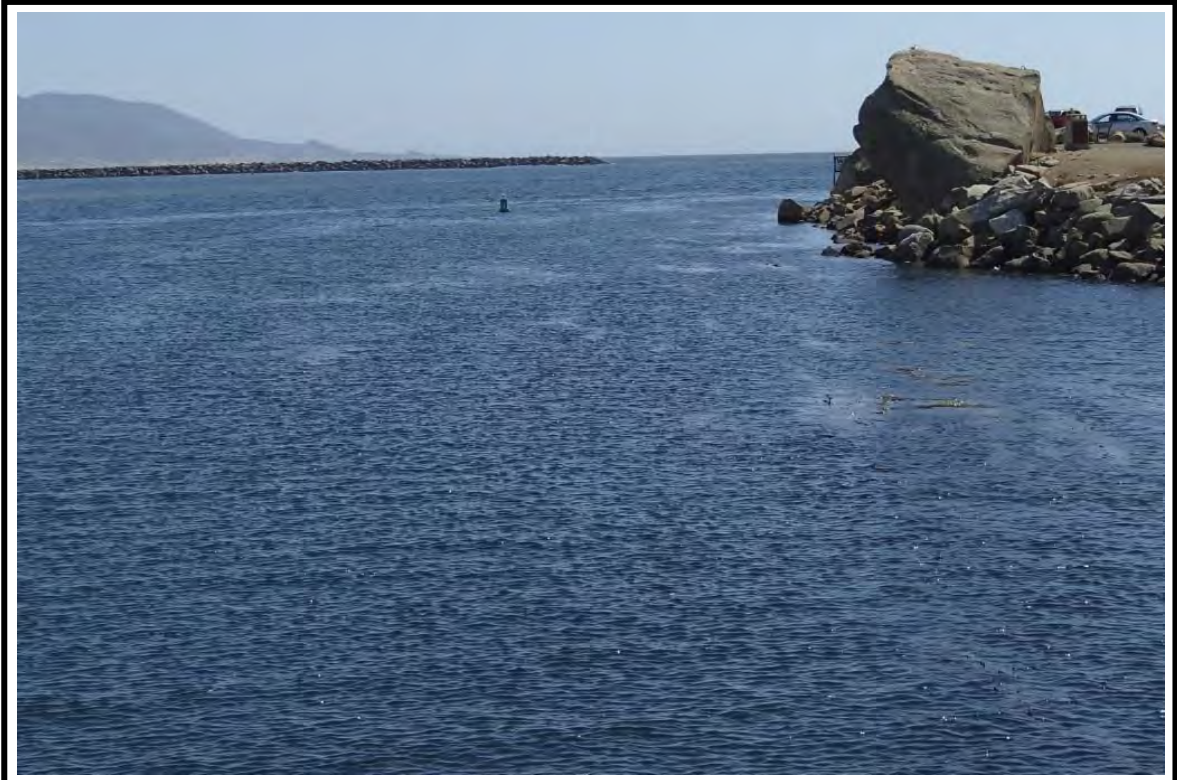
Photo 4a. Target Rock shoreline area with surface slicks on wave rippled water revealing canopy kelp presence.

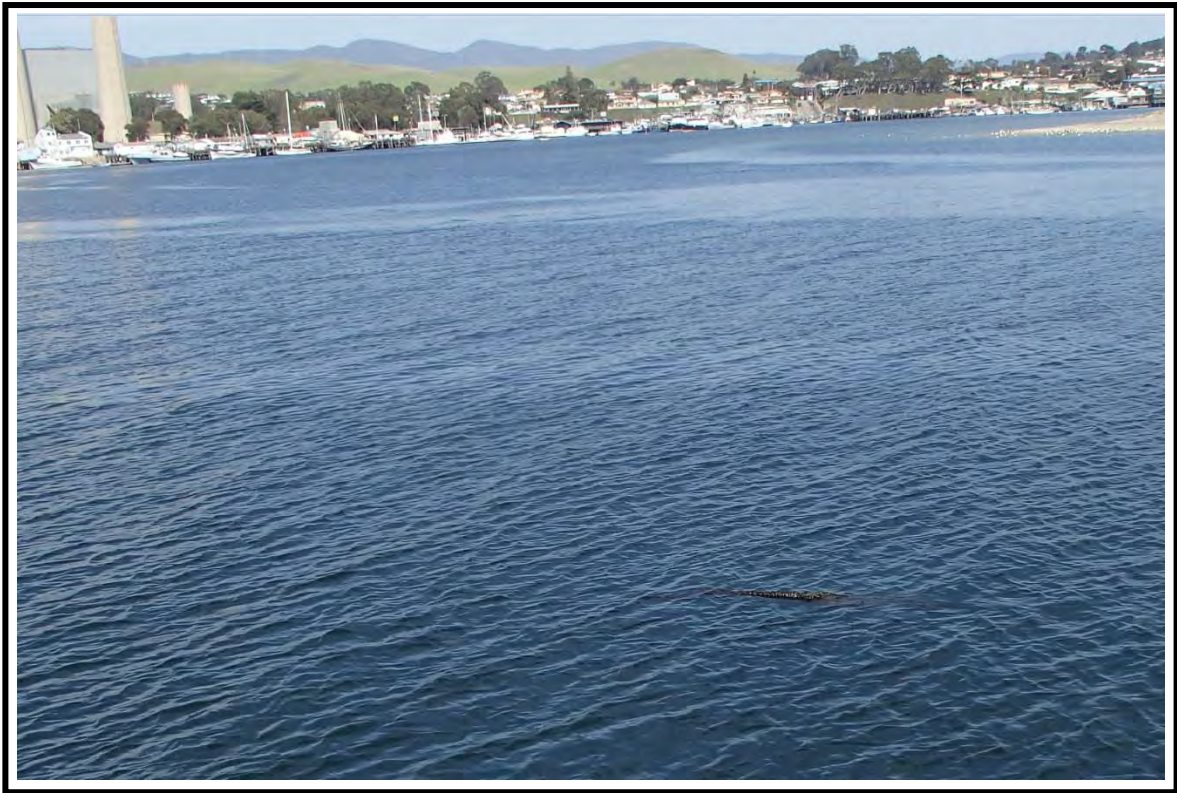
Photo 4b. Minor occurrences of bull kelp were noted on the outer perimeter of the giant kelp bed within the western portion of the Navy Channel.

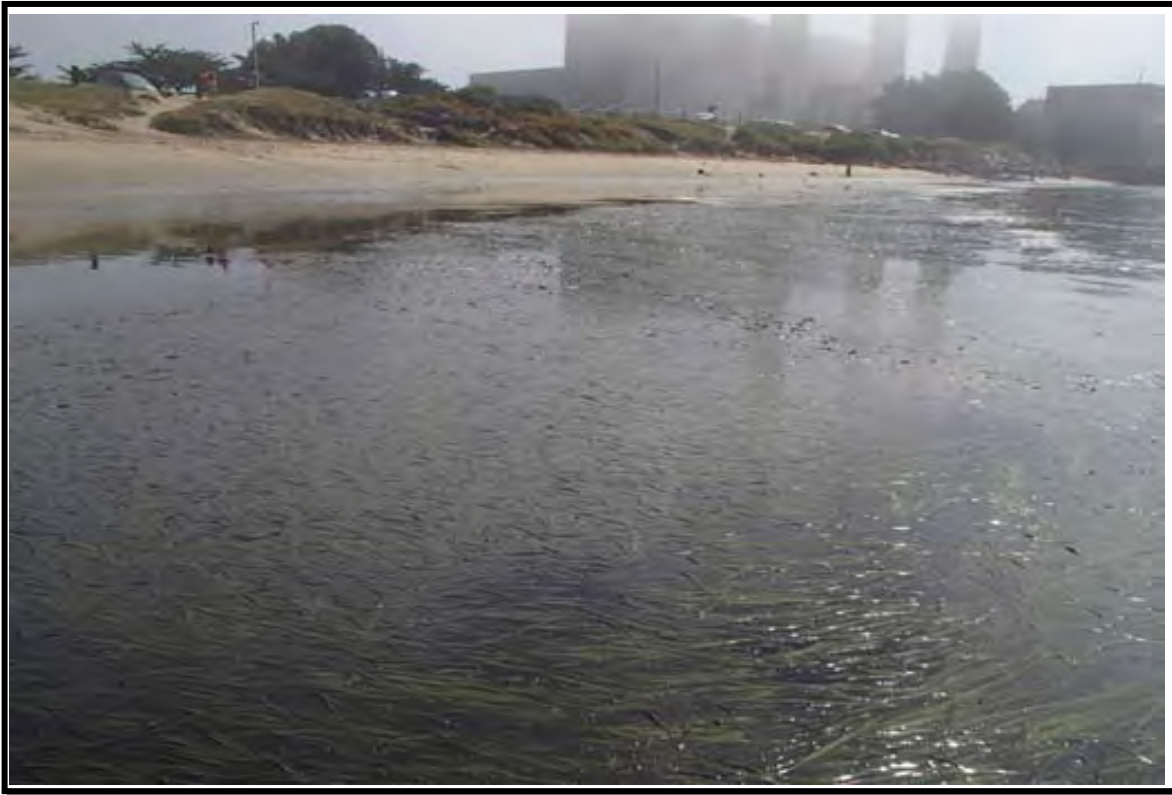
Photo 5a. Low tide exposed eelgrass bed at Coleman Beach.

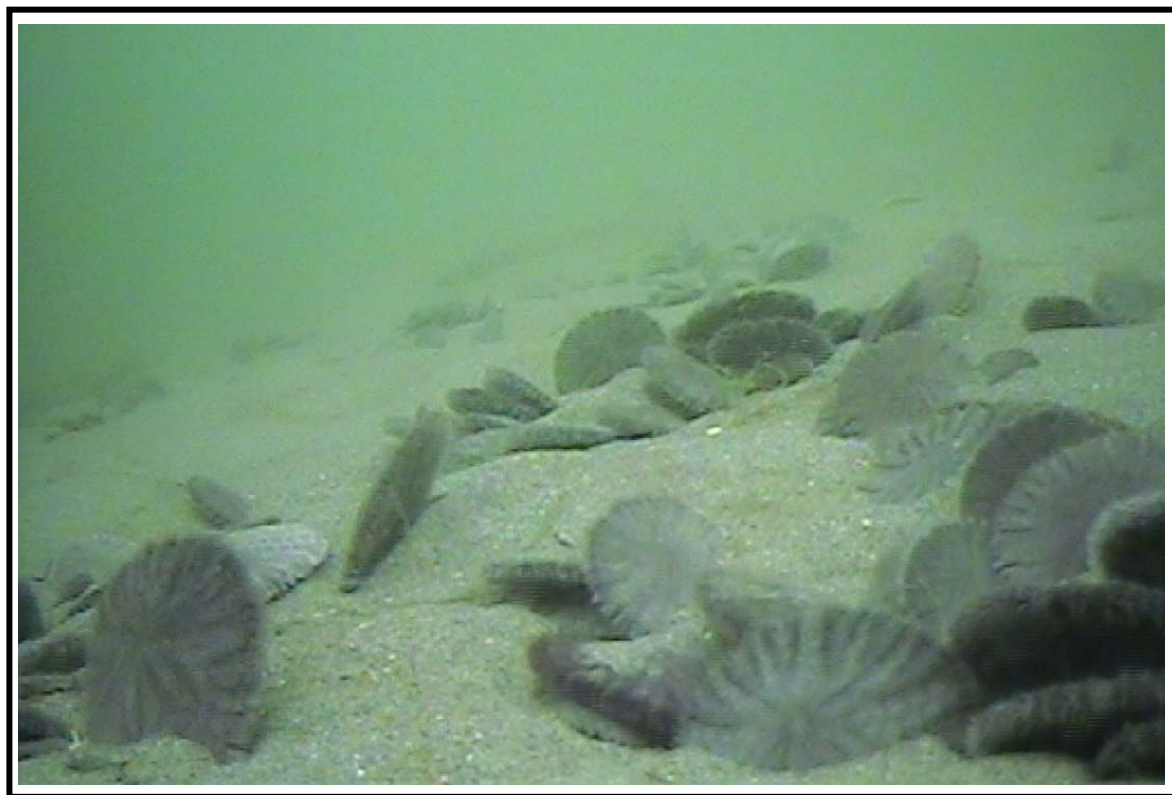
Photo 5b. Sand dollar beds (*Dendraster excentricus*) have become more expansive in the northern portions of the Bay over the past few years. These beds are located on the building shoal along the west side of the Navy Channel.
