# Check Point Survey Report

**“CA\_FEMA R9 Lidar\_2016\_D17”  
ALPINE**

**USGS Contract: G10PC00013  
Task Order Number: G17PD00044**

**Prepared for:  
*United States Geological Survey (USGS)***

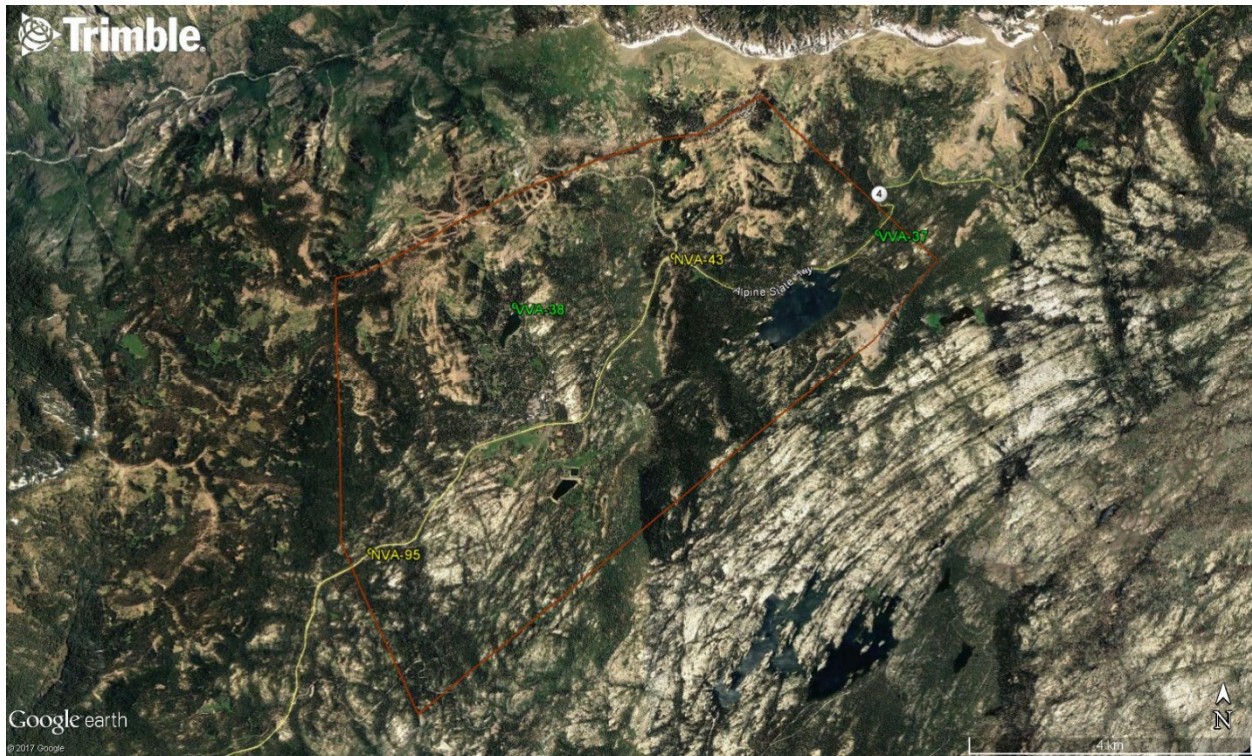
### 1.3 Project Area

The 4 LiDAR Check Points were well distributed throughout the project area.

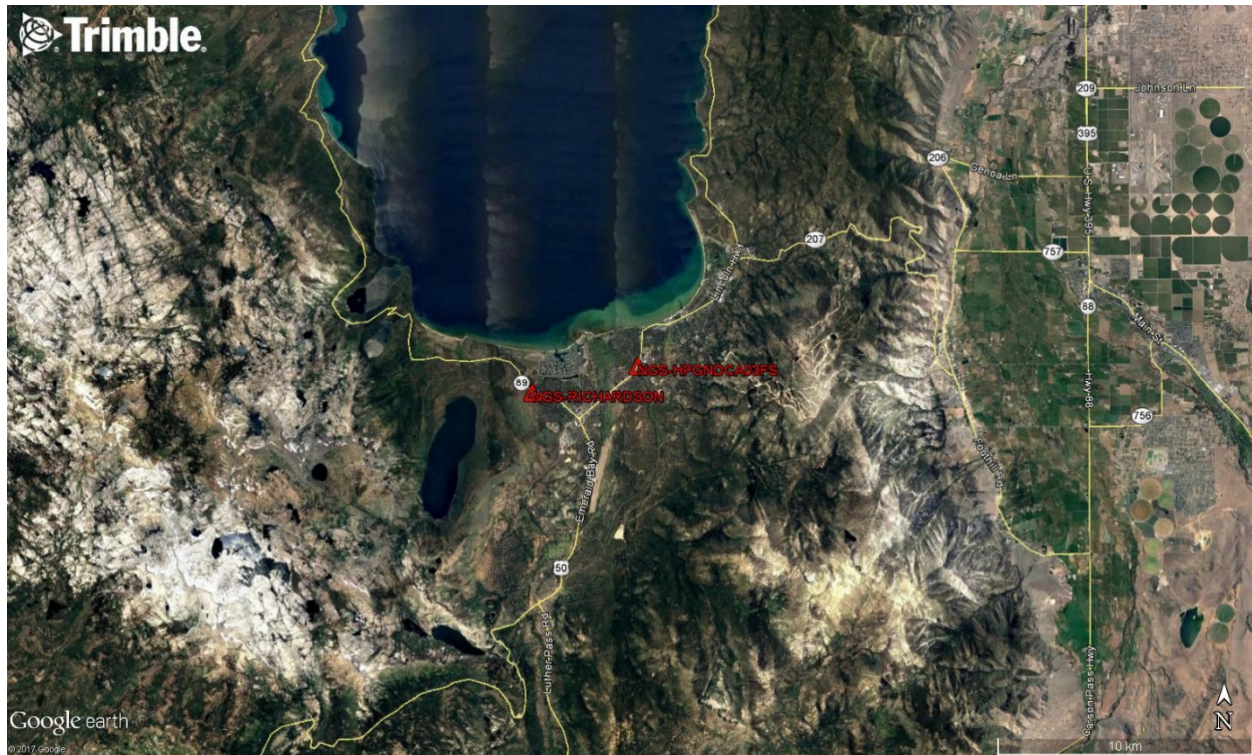
## NGS Monuments

Two (2) existing NGS monument listed in the NSRS database were located as an additional QA/QC method to check the horizontal and vertical accuracy of the VRS network as well as being the primary project control monuments designated as DH6449 and AE9848. The results are as follows:

PT. #	Observed Values			Data Sheet Values			$\Delta X$	$\Delta Y$	$\Delta Z$
	NORTHING	EASTING	ELEVS.	NORTHING	EASTING	ELEVS.			
NGS- HPGNDCA03FS	2107517.08	7136557.85	6248.27	2107517.07	7136557.88	6248.20	0.01	-0.03	0.06
NGS- RICHARDSON	2103838.91	7123525.99	6247.13	2103838.87	7123525.92	N/A	0.04	0.07	N/A

The above results indicate that the VRS network is providing positional values within the 5cm parameters for this survey.
